UNITY 600 upgrade to UNITY600 Plus:

Lock signal problem:

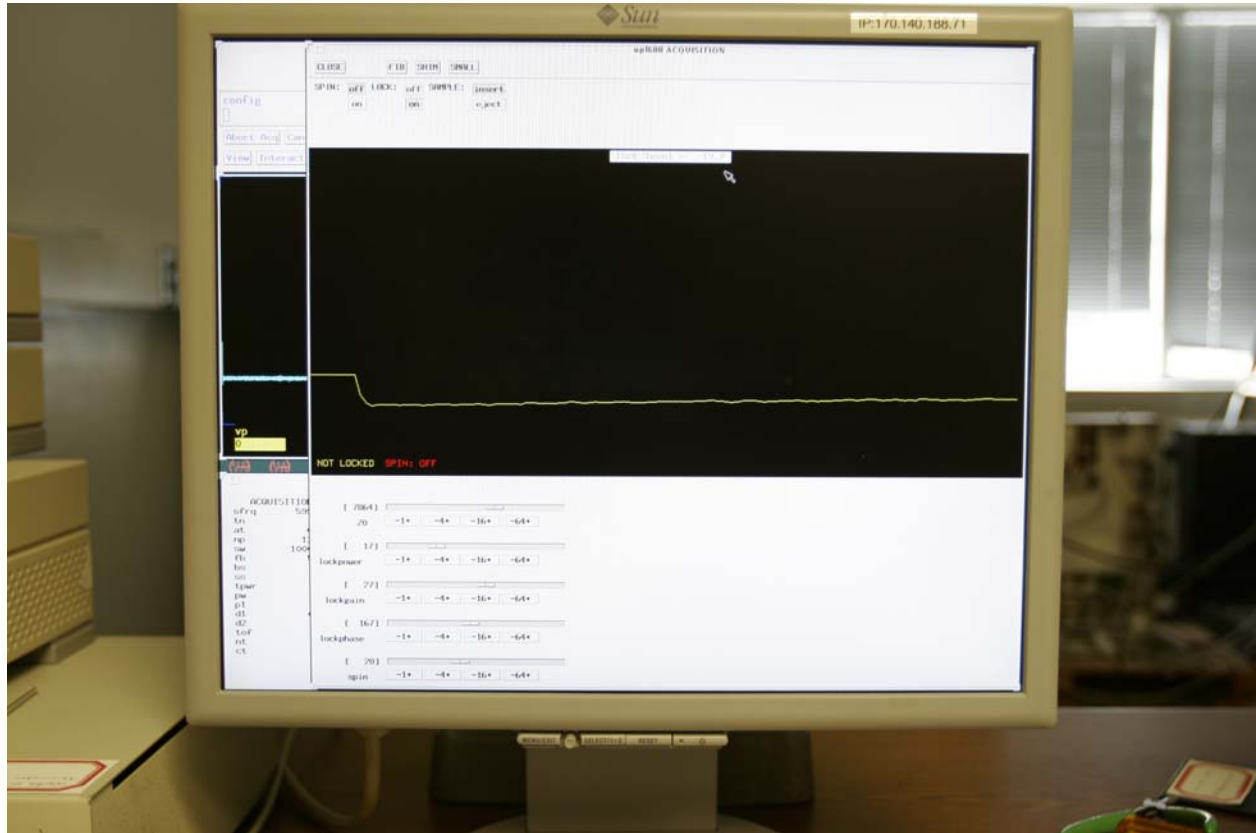
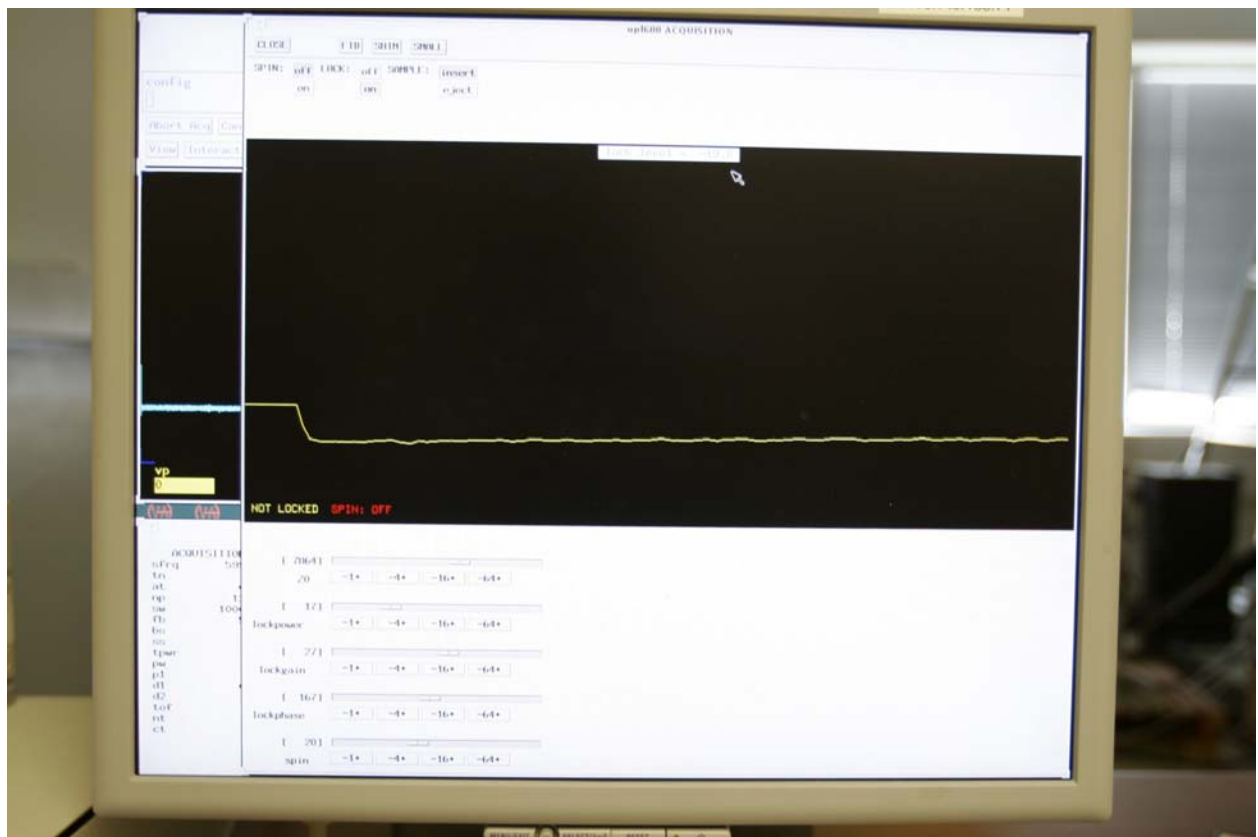
It could be locked, but the signal is 180 degree difference.

It is required to reset the polarity switch on one of the shim board:

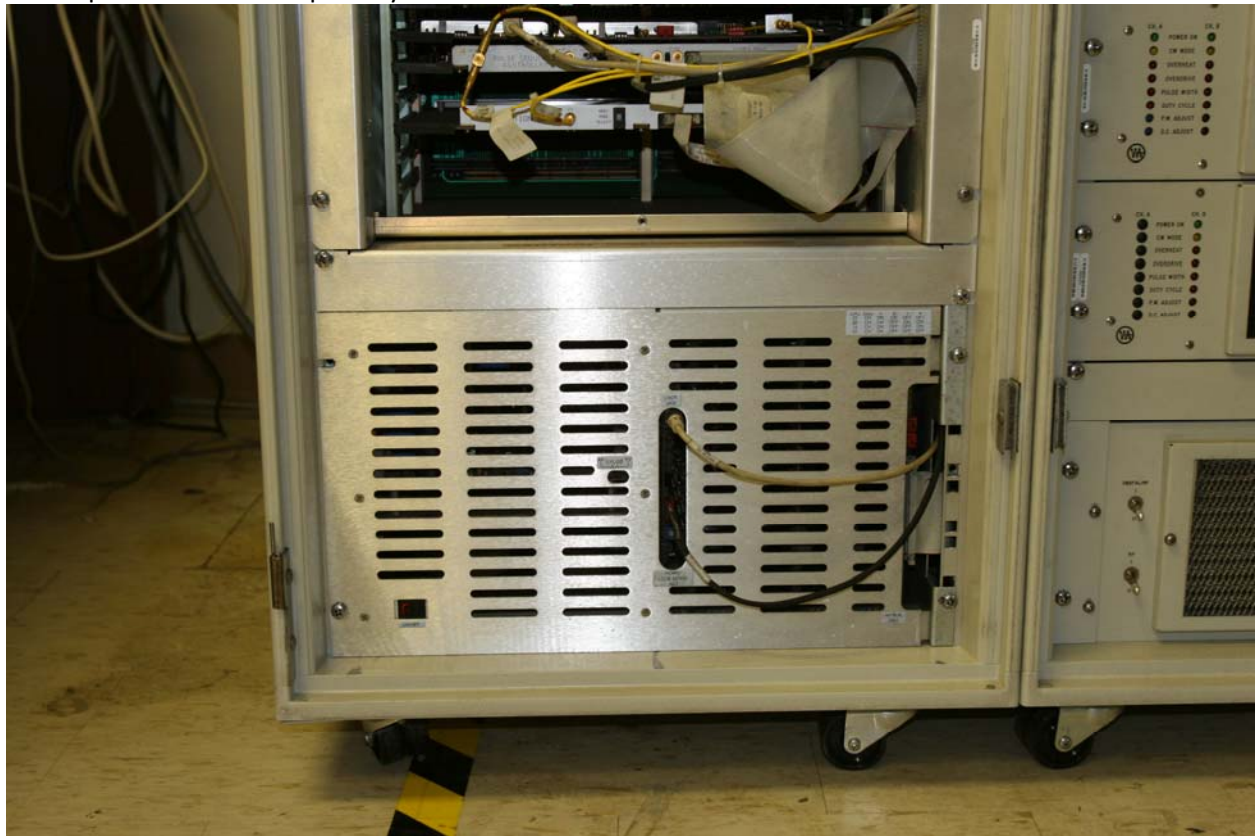
Shim power supply unit on the unity plus console.

Open the ship power supply unit.

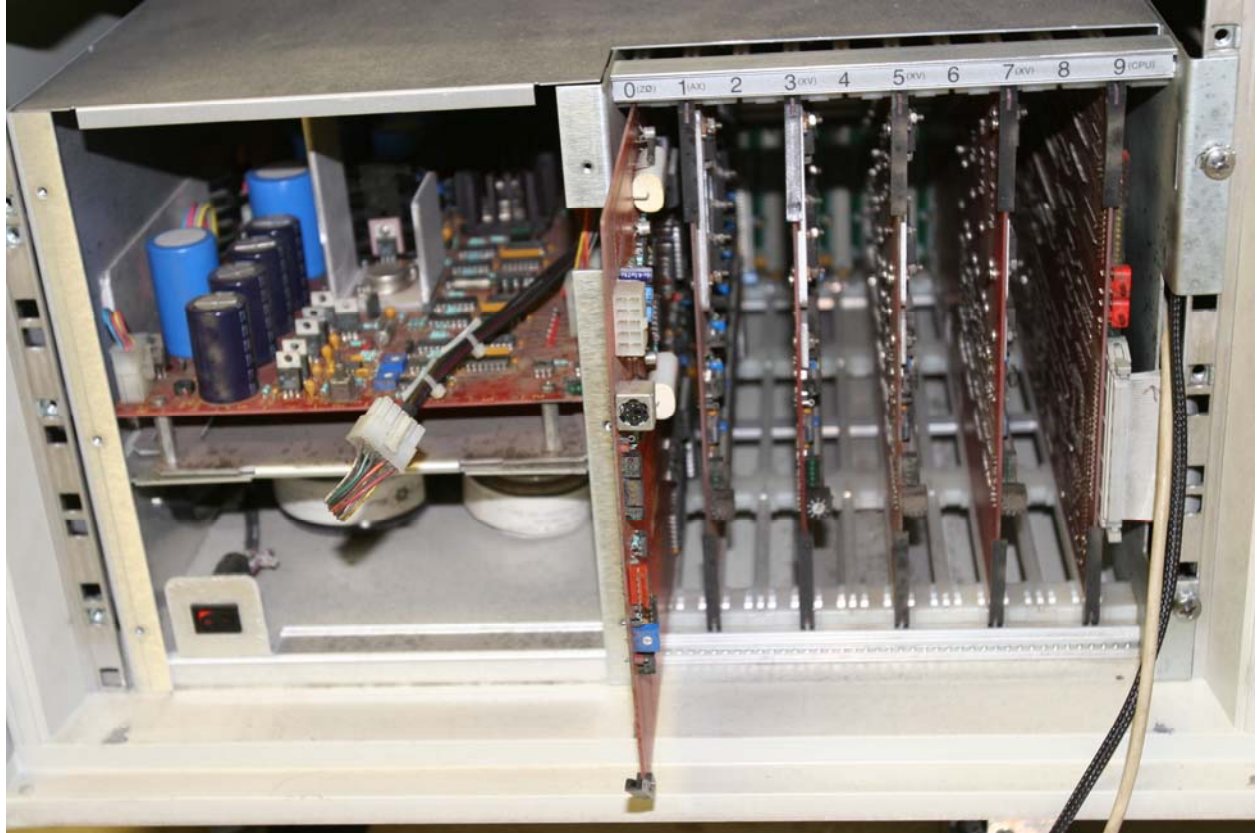
The lock signal should be reversed.
